PHOTO MOUNTING SHEET

Insured: Asheville Crane, Inc.	Claim Number: ILM216252
Date Taken: 11/11/2011	Our File Number: 1111-01617-KS

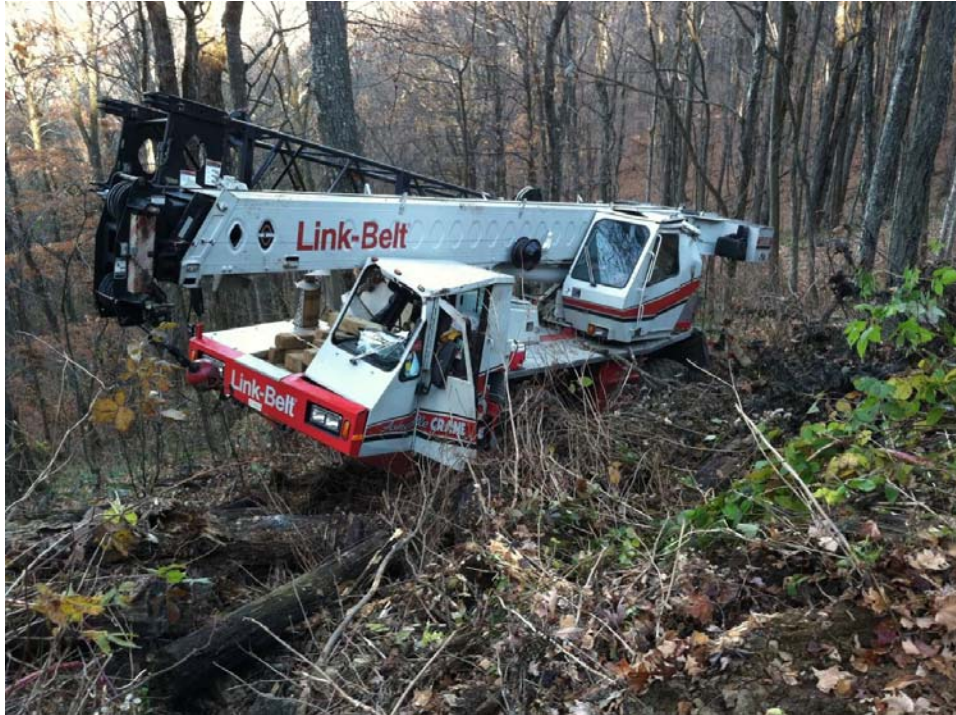
Photo #1: View of 2003 Linkbelt ATC-822, 22-ton, All-Terrain Crane SN: 71J35776, with 70' main and 45' jib.

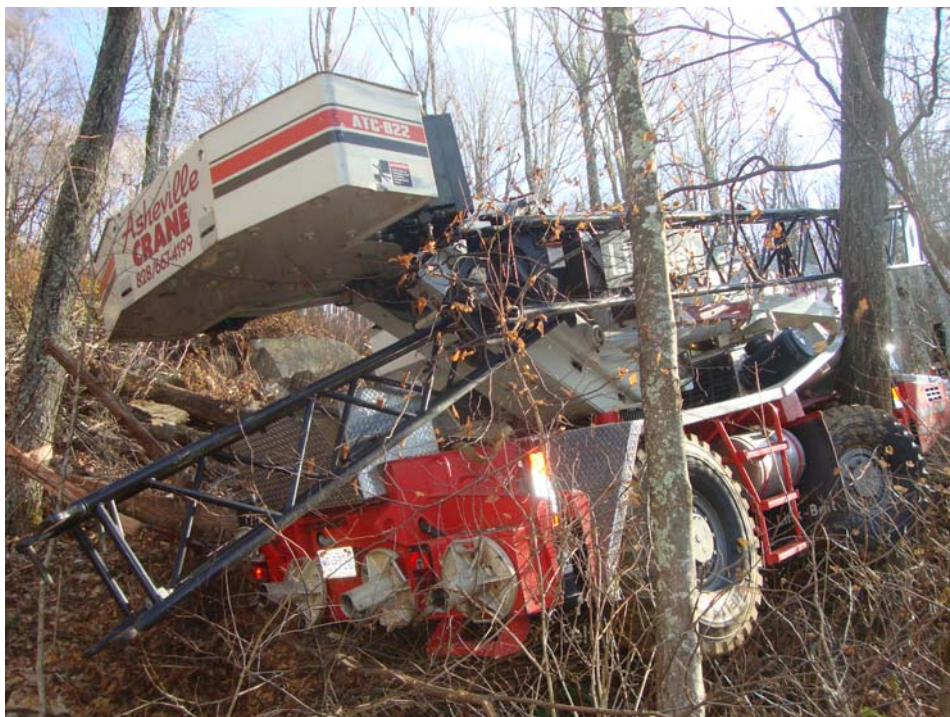
Photos #2: Unit hit soft spot and rolled down the side of a mountain about 20'-25' from driveway.

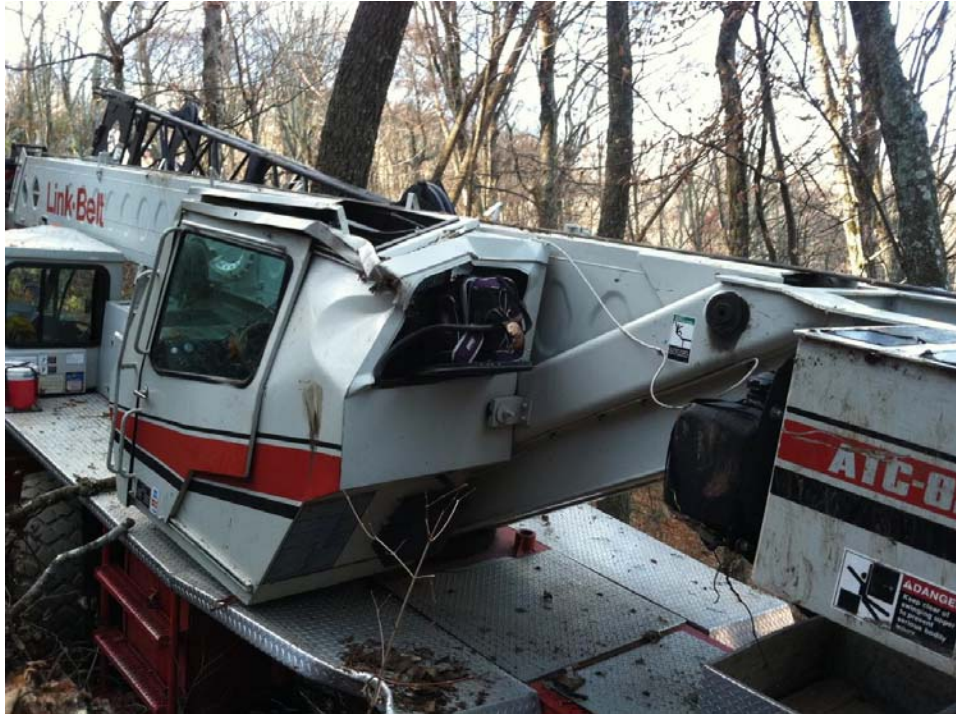
Photo #3: View depicting damage to boom cab and aluminum decking.

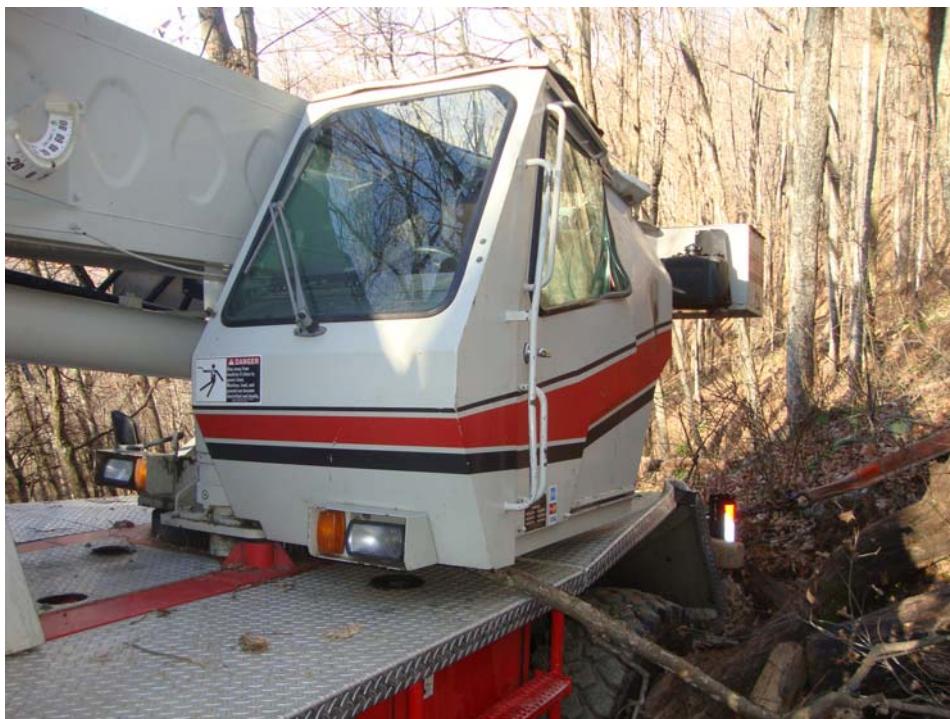
Photo #4: Front view of boom cab.

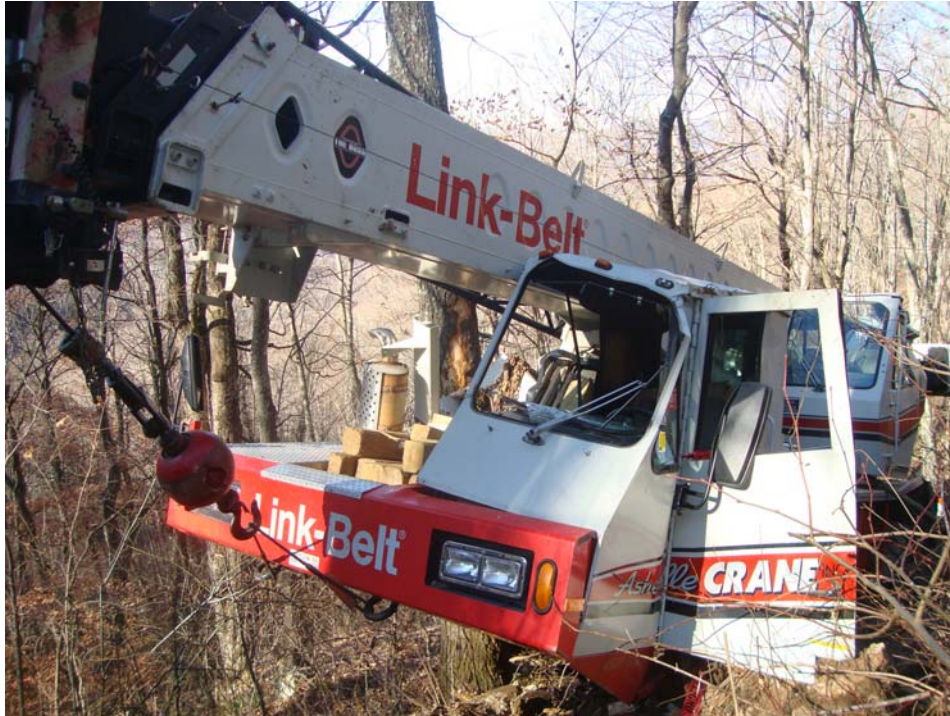
Photo #5: Front view – depicting damage to carrier cab.

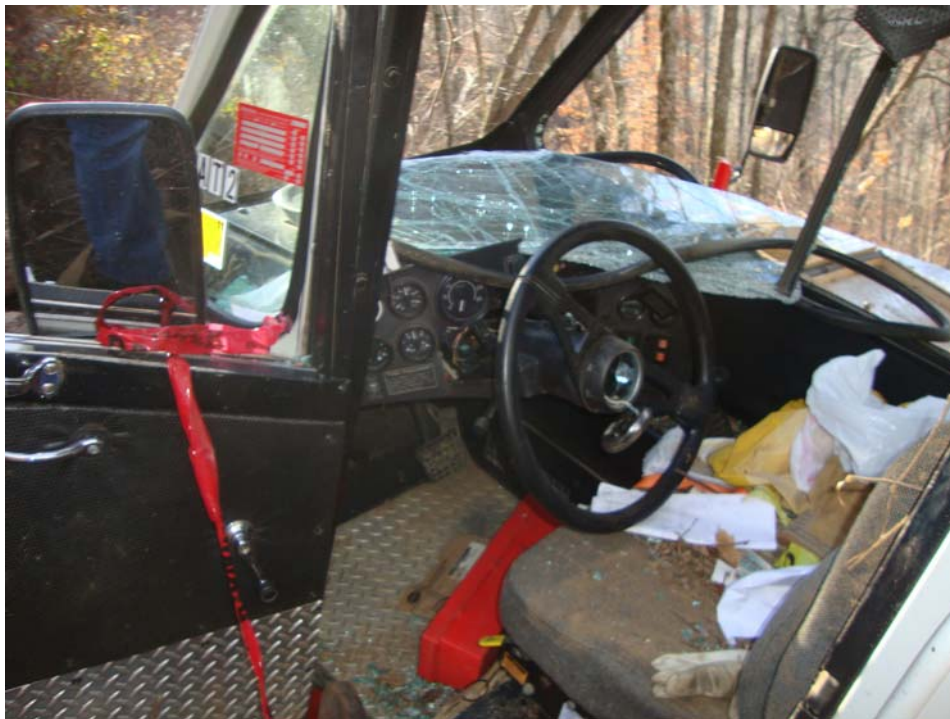
Photo #6: Interior view of carrier cab.

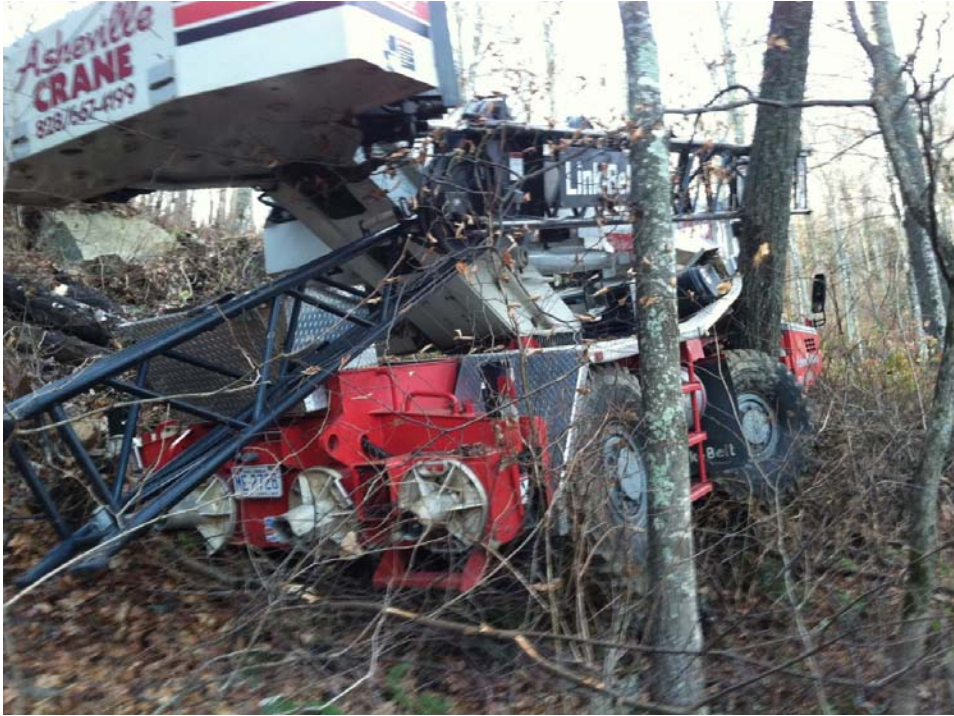
Photo #7: View depicting damage to jib and fly.

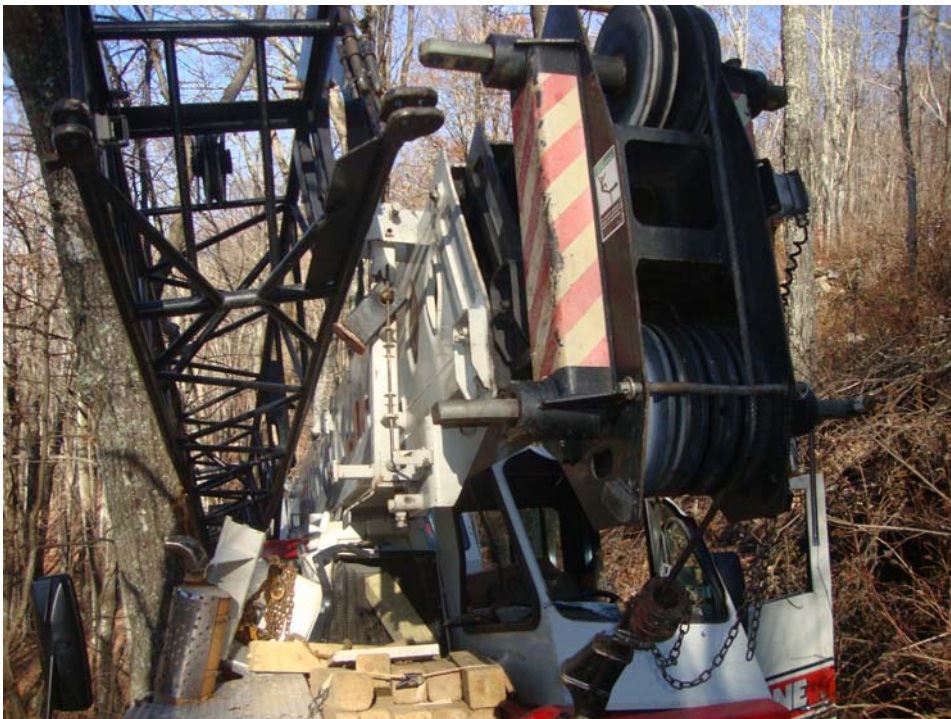
Photo #8: Equipment lodged against tree. Impact damaged jib.

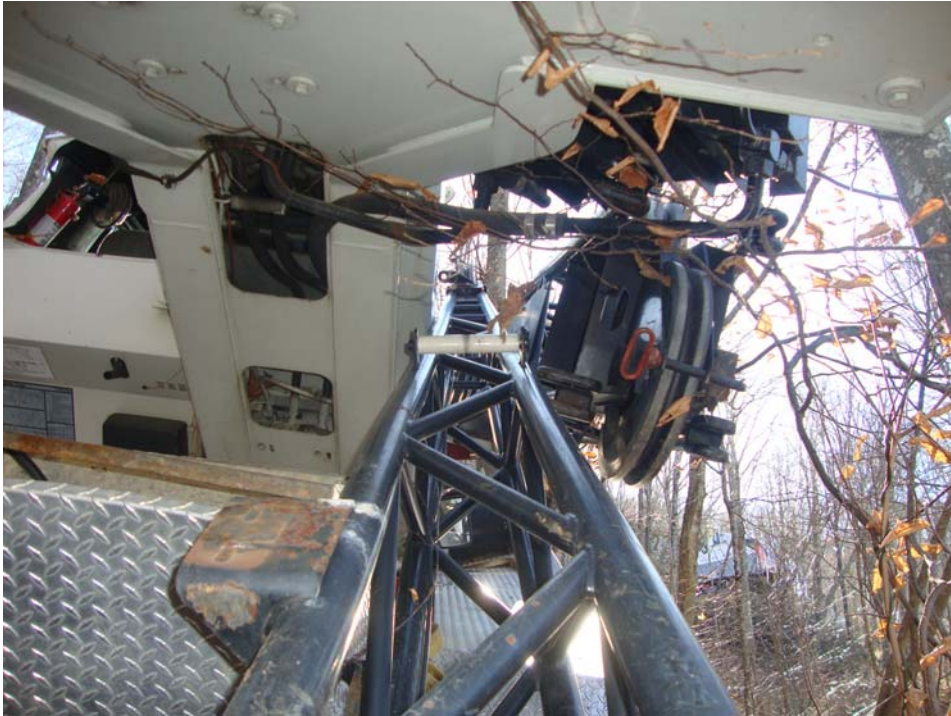
Photo #9: View depicting fly.

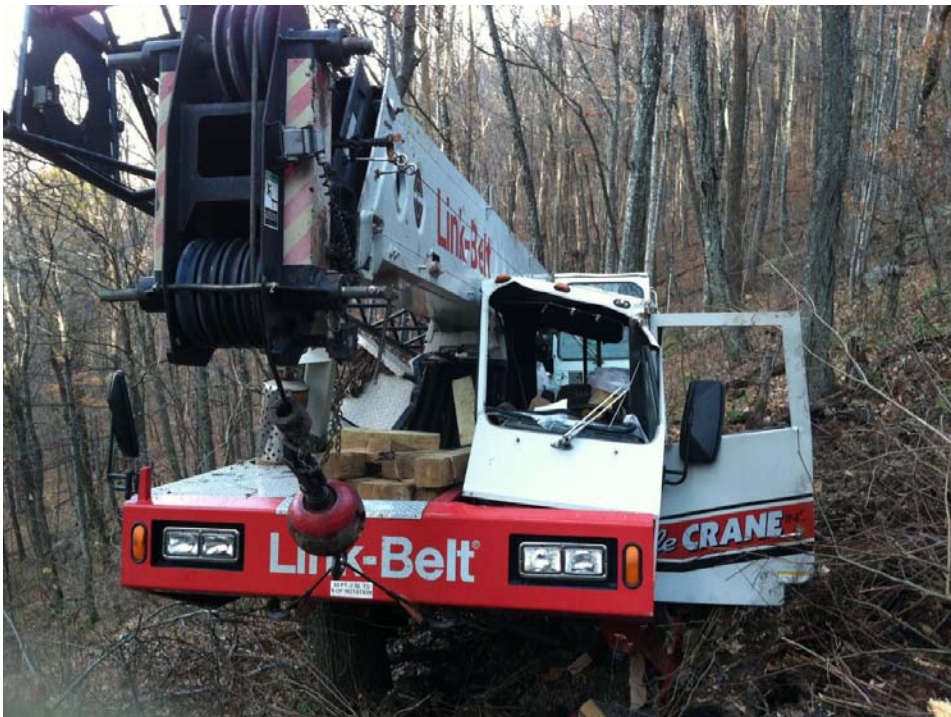
Photo #10: Front view of unit on side of mountain.

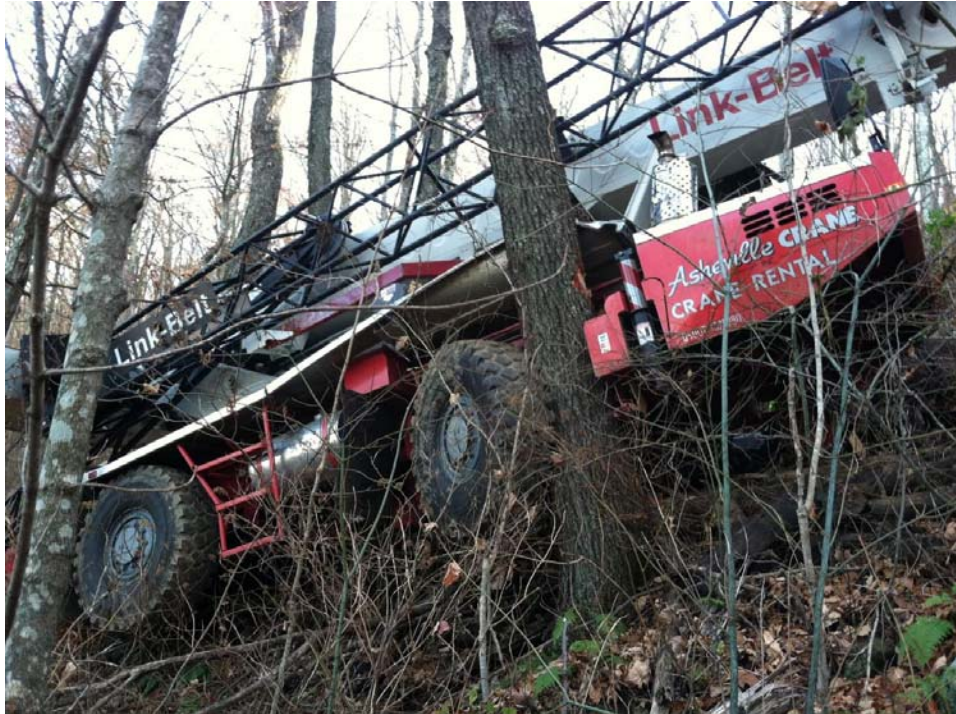
Photo #11: Right side view of boom truck lodged against tree on side of mountain.

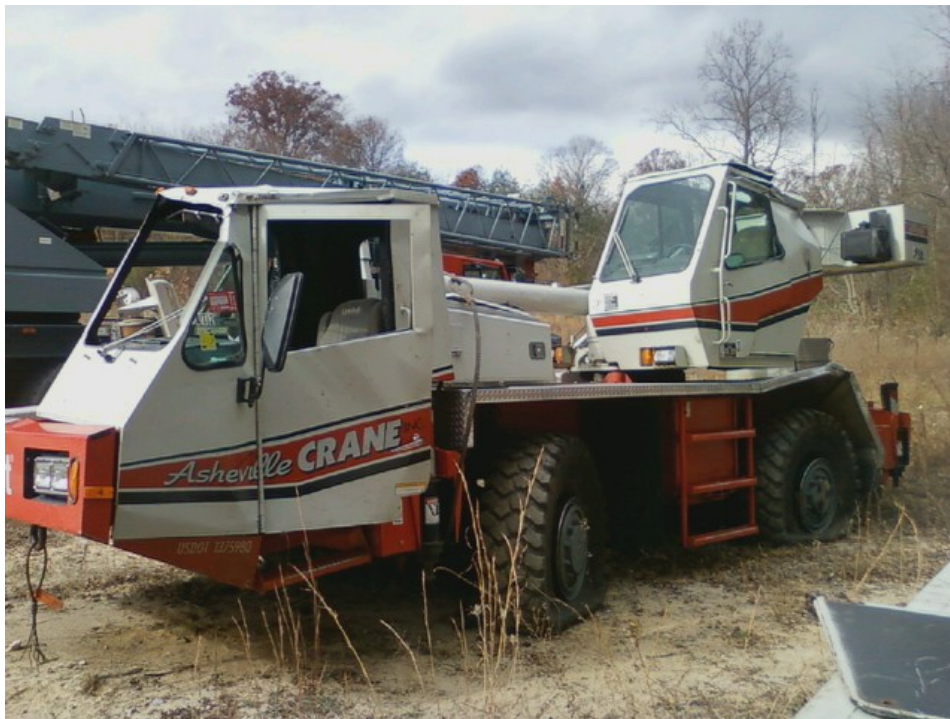
Photo #12: View of crane recovered from loss site.

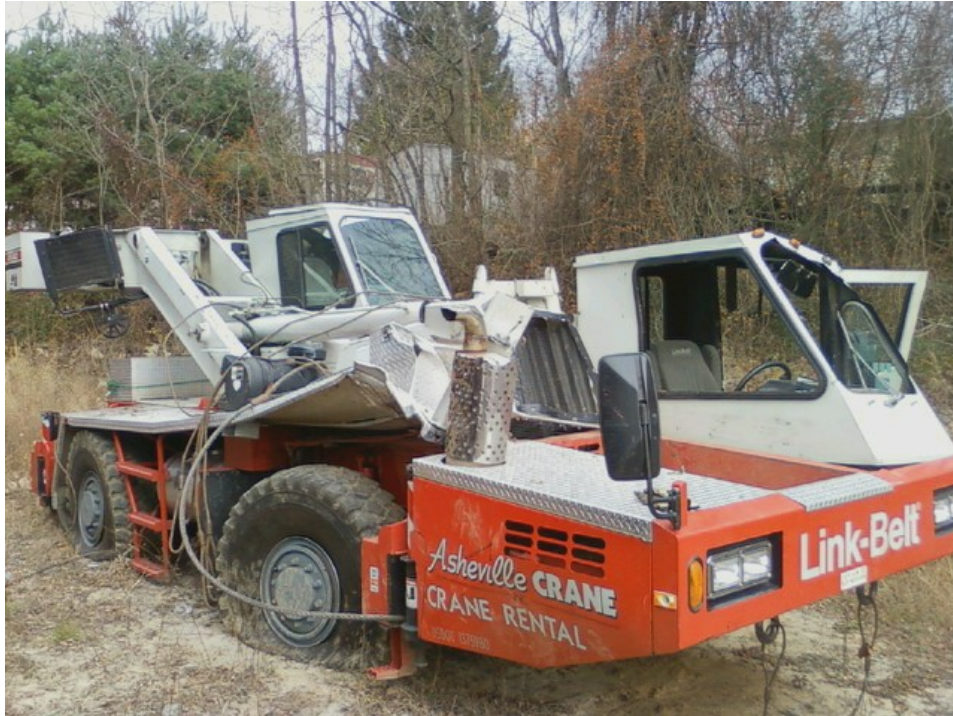
Photo #13: Right side view of boom truck recovered from site. Boom has been removed.

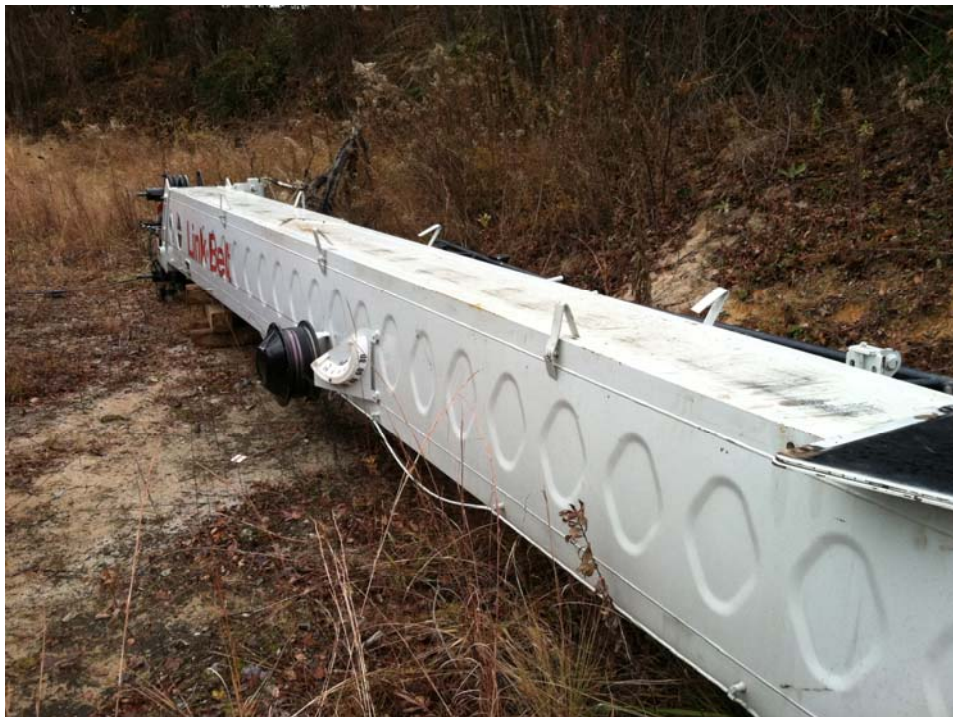
Photo #14: View depicting boom section.

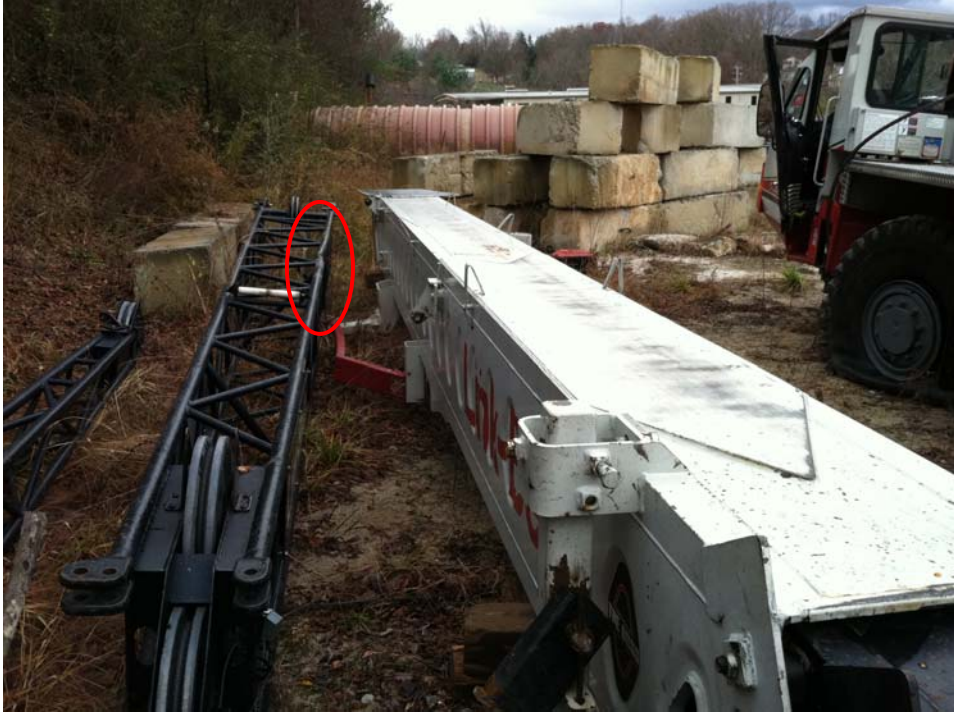
Photo #15: View depicting boom and jib. Damage to jib from impact. No visible damage to boom.

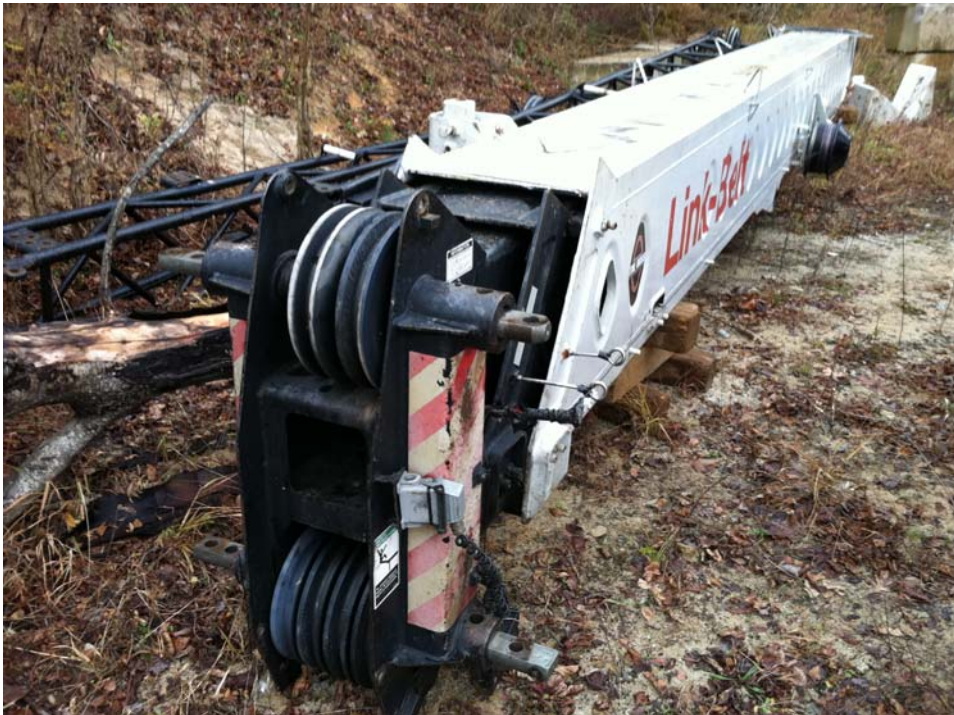
Photo #16: View of boom sections.

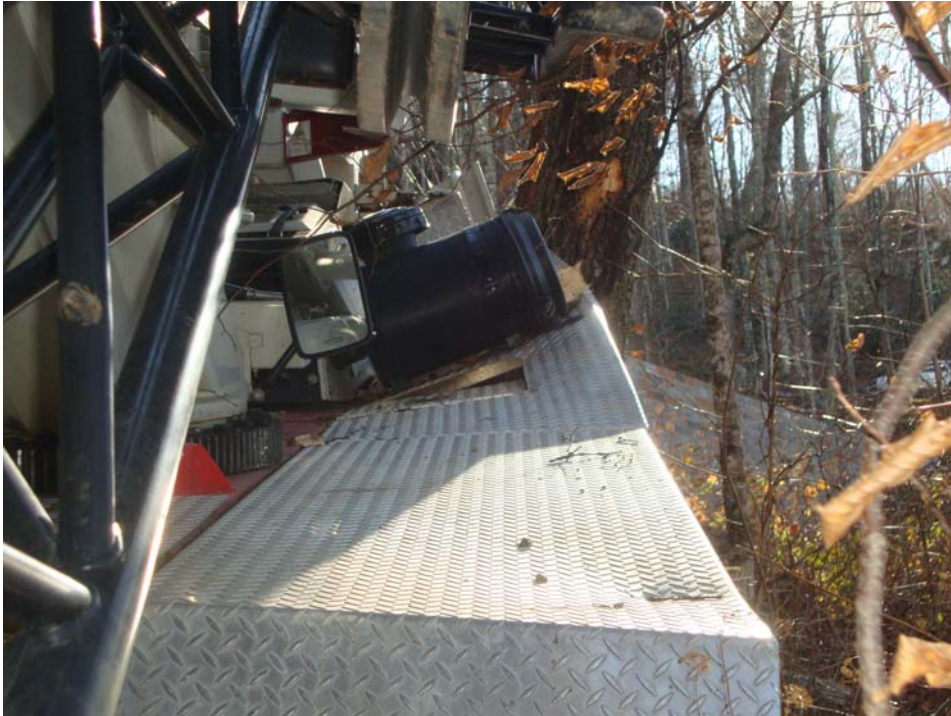
Photo #17: Additional view of platform decking.

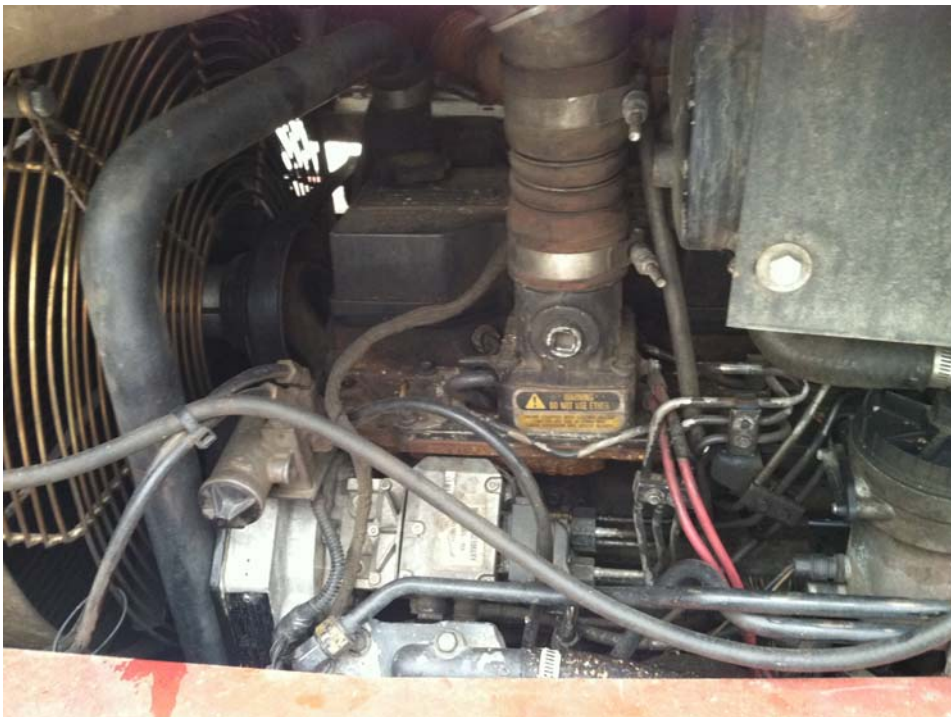
Photo #18: View of Cummins 6-cylinder, ISB series engine. No visible damage to engine.

(Radiator/cooling system is damaged).

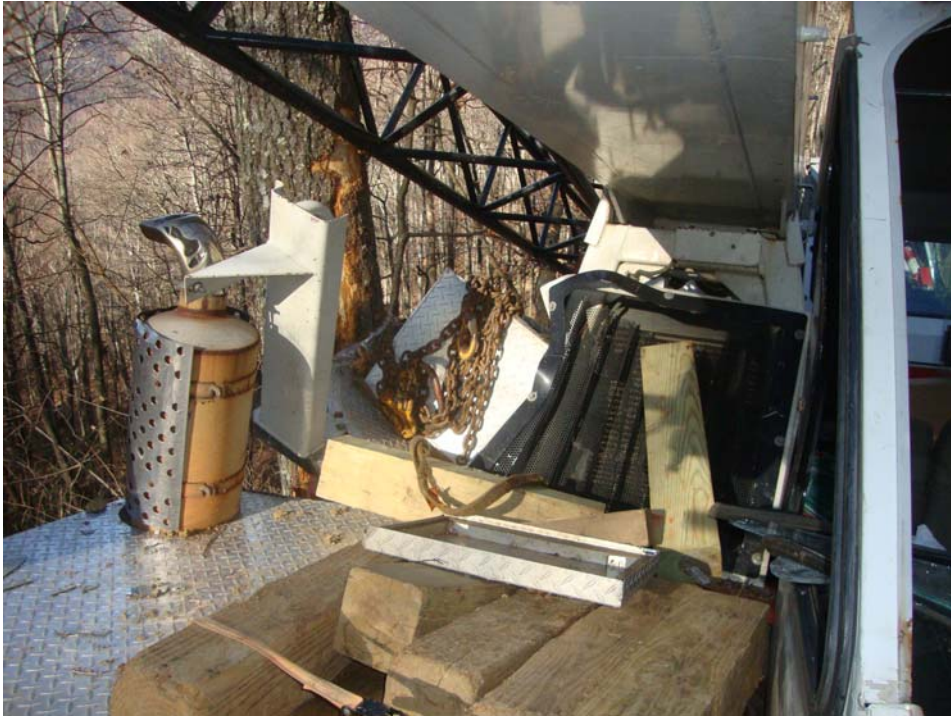
Photo #19: Radiator/Cooling system sustained damaged from impact.

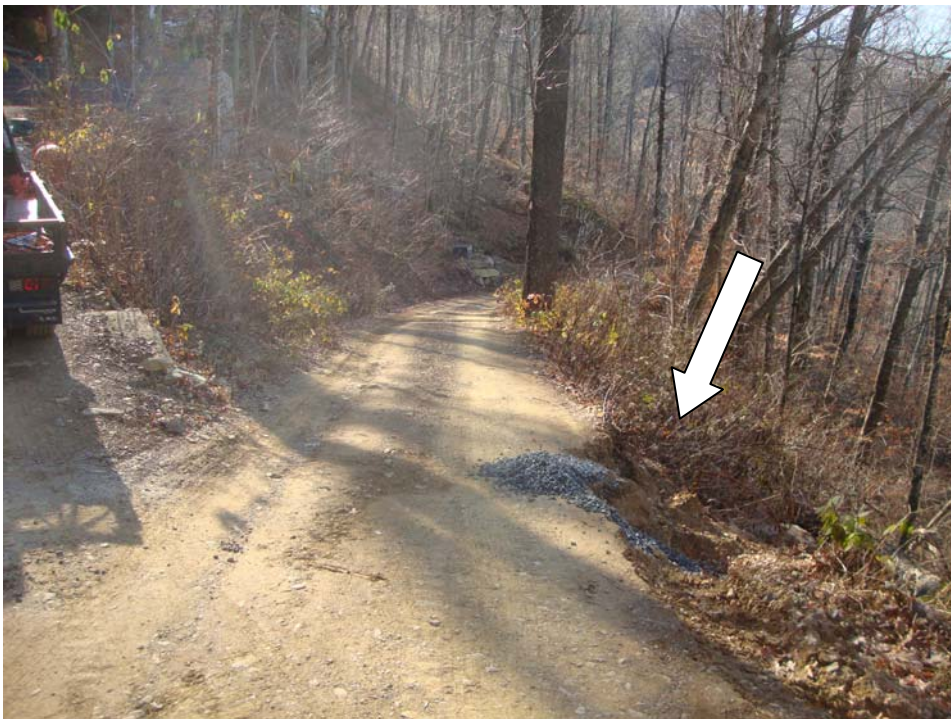
Photo #20: View of loss location. Insured was operating unit down driveway, hit soft spot and rolled over down mountain approx. 20'.

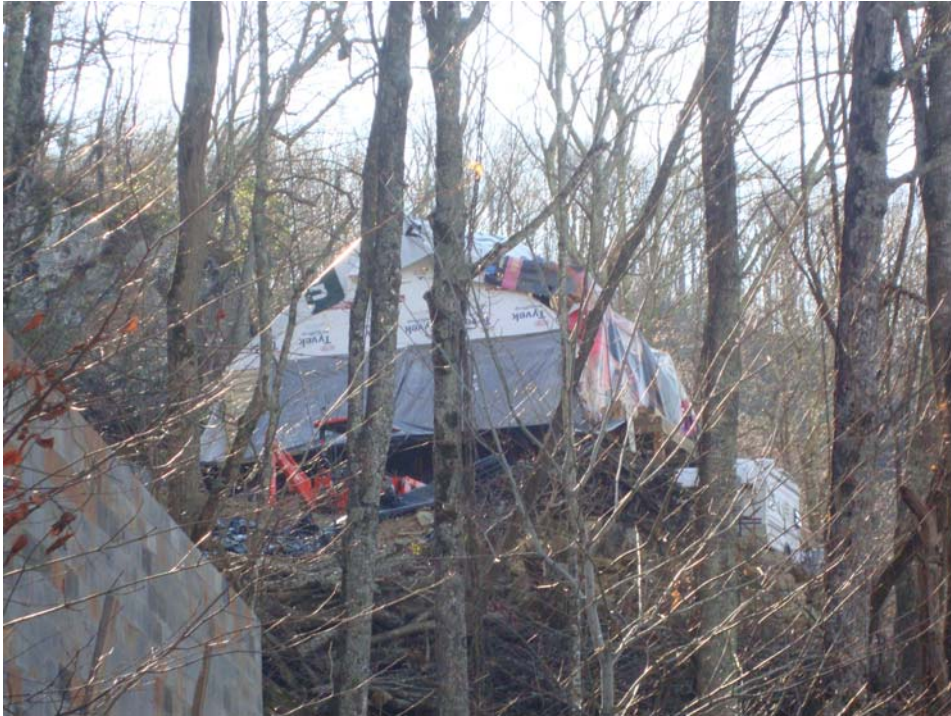
Photo #21: Insured's work included the truss erection for homeowner's new building on mountain site.
