## Property Damage Appraisers (PDA Toledo)

Type of Loss: Property Damage  
 Arrival Date: 4/10/2015  
 Accident Date: 4/ 8/2015

Description: 2005 Mack Vision CX  
 Type/Component: Truck  
 VIN: 1M1AK07Y95N007016  
 Mileage: 547,796  
 OEM/ALT: O  
 Color: White

| | | <b>TOTAL LOSS</b> |

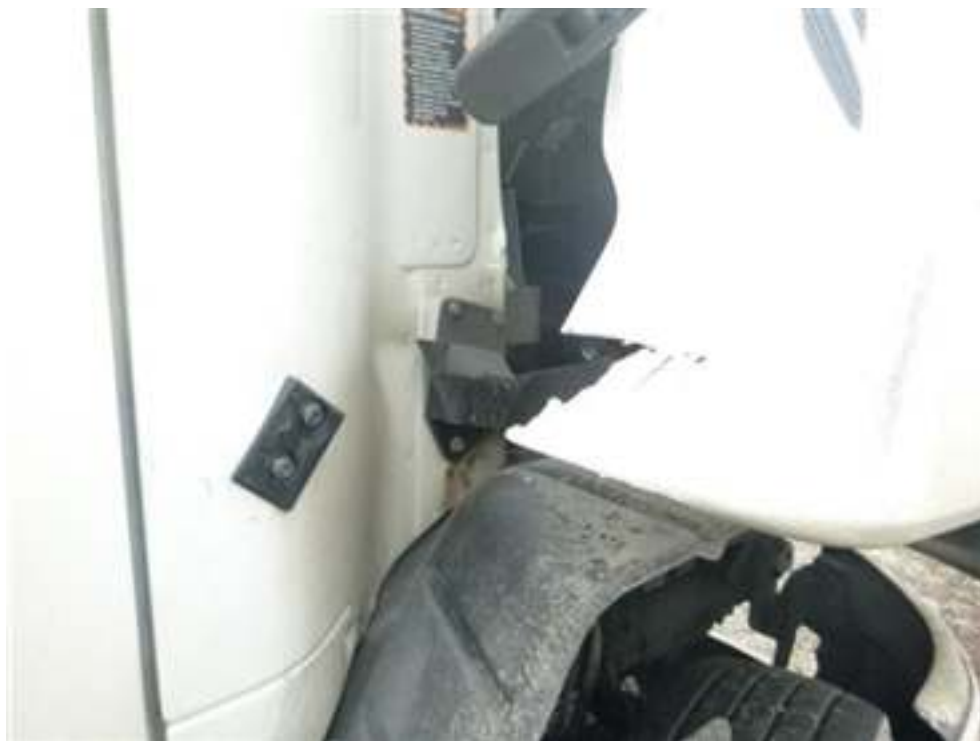
Document Name: P1050471.JPG

Remarks: Rt cowel damage

| 37 | 100406 | BDY | REPAIR | Cab Front Panel | | Existing | | | 6.0* # |

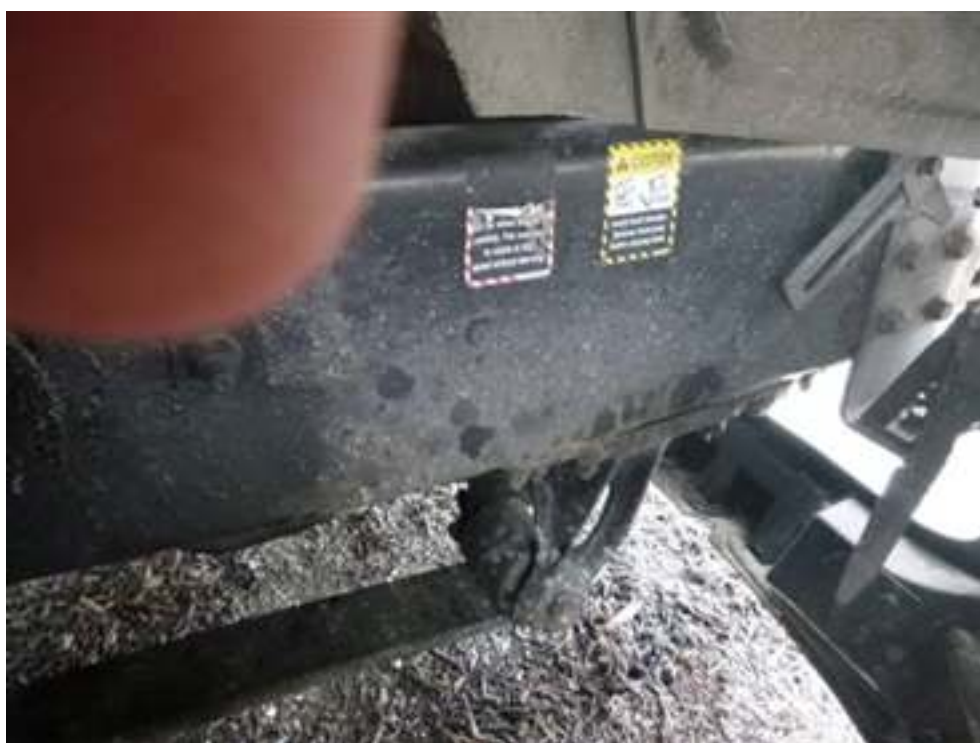
Document Name: P1050472.JPG

Remarks: Rt frame rail damage

| Line Item | Entry Number | Labor Type | Operation | Line Item Description | Part Type/<br>Part Number | Dollar Amount | Labor Units |
|---|---|---|---|---|---|---|---|
| 20 | 100164 | FRM | REPAIR | R Frame Rail -F | Existing | | 9.0* # |

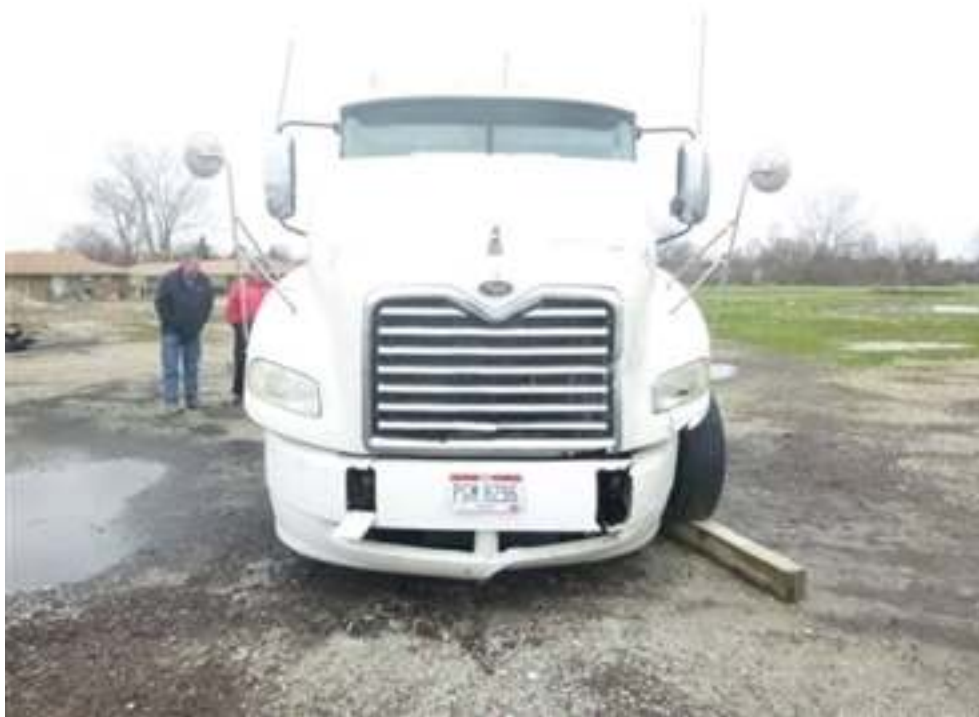
Document Name: P1050455.JPG

Remarks: Frt view

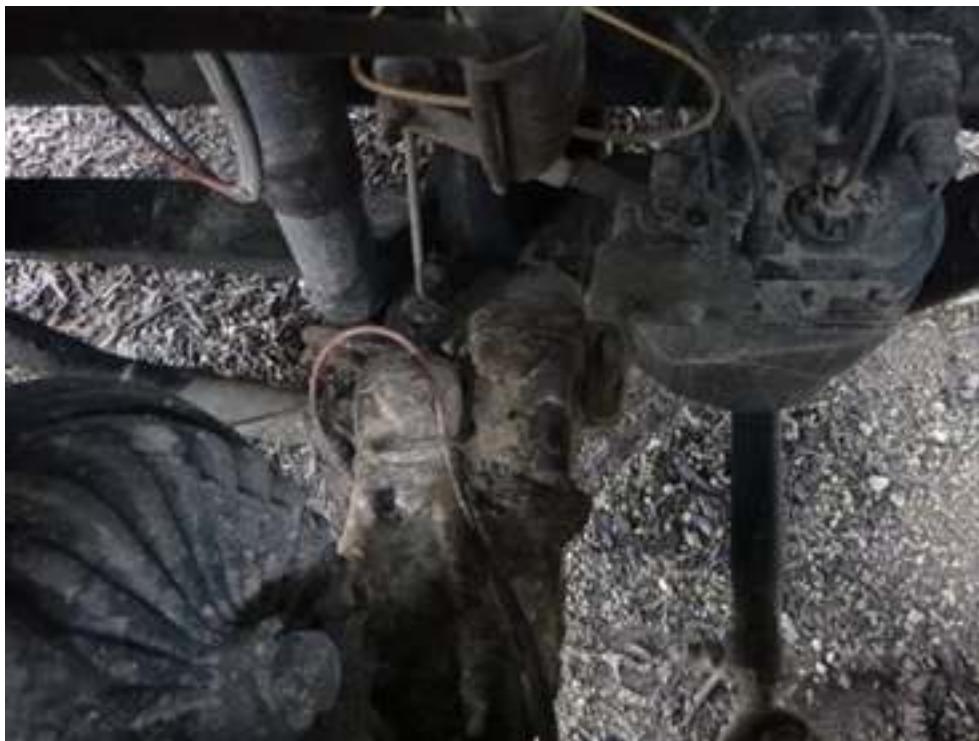
Document Name: P1050457.JPG

Remarks: Frt axle damage

| 31 | 100251 | MCH | REMOVE/REPLACE | Frnt Susp Axle | -M | N.A. | 4,387.00 | * | 9.0 |

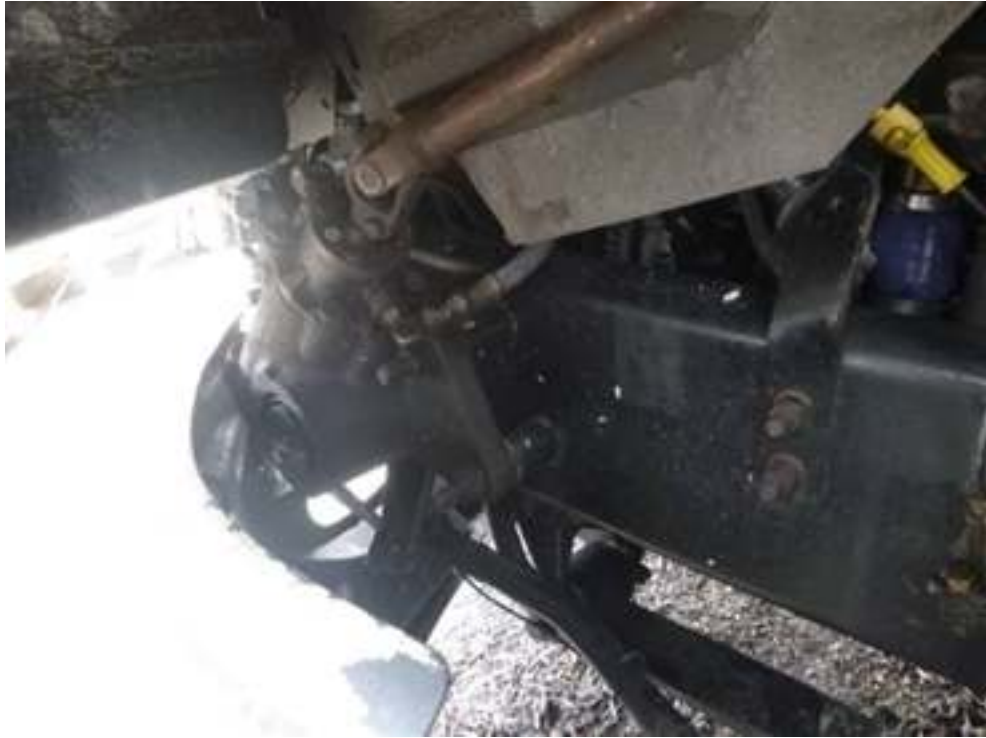
Document Name: P1050458.JPG

Remarks: Lt frame rail damage,good chance that gear box and coolers have damage ,cannot raise hood

| Line Item | Entry Number | Labor Type | Operation | Line Item Description | Part Type/<br>Part Number | Dollar Amount | Labor Units |
|---|---|---|---|---|---|---|---|
| 21 | 100165 | FRM | REPAIR | L Frame Rail -F | Existing | | 9.0* # |

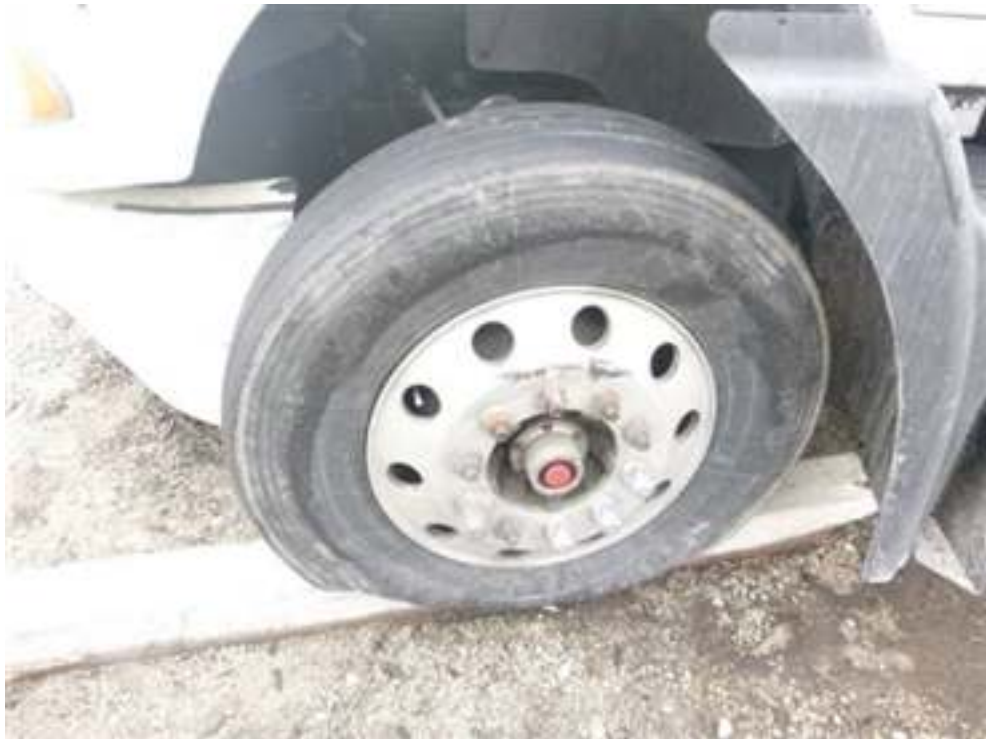
Document Name: P1050459.JPG

Remarks: Lt frt wheel and tire damage

| Line Item | Entry Number | Labor Type | Operation | Line Item Description | Part Type/<br>Part Number | Dollar Amount | Labor Units |
|---|---|---|---|---|---|---|---|
| 29 | 101129 | MCH* | REMOVE/REPLACE | Alloy Wheel 2@352.38 | Qual Recycled Part | 704.76 * | 2.8* # |

| 49 | 900500 | MCH * | REMOVE/REPLACE | Lt Frt Steer Tire | | New | 597.00 | * | 0.8* |

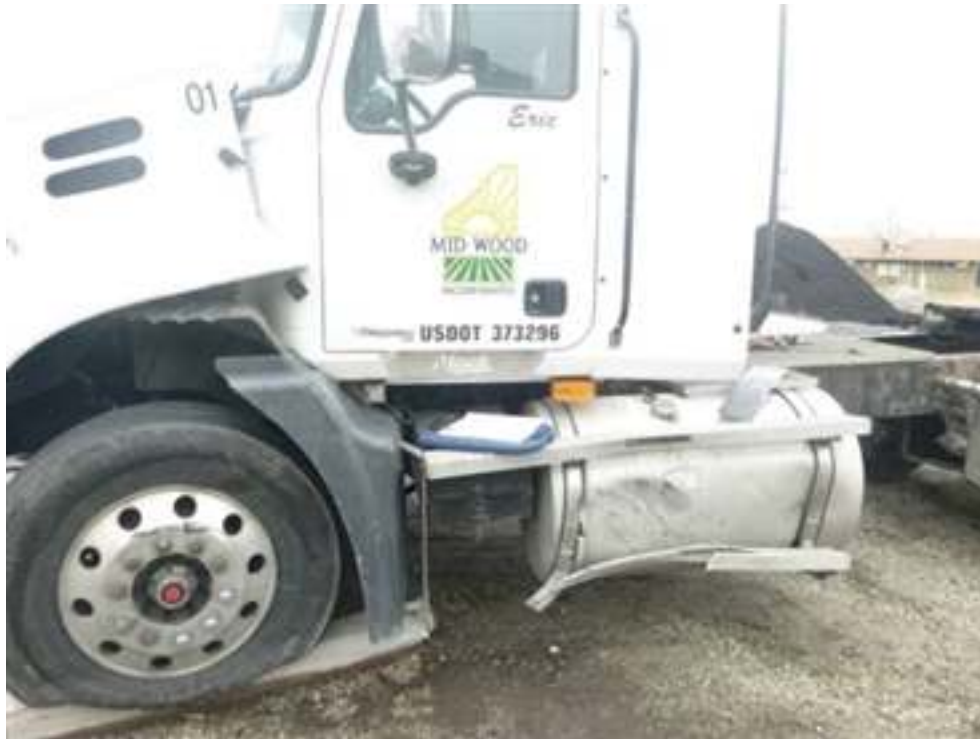
Document Name: P1050460.JPG  
Remarks: Lt fuel tank and step damage

| Line Item | Entry Number | Labor Type | Operation | Line Item Description | Part Type/<br>Part Number | Dollar Amount | Labor Units |
|---|---|---|---|---|---|---|---|
| 23 | 100196 | BDY | REMOVE/REPLACE | L Fuel System Tank | N.A. | 1,727.44 * | 2.0 # |
| 24 | 100228 | BDY | REMOVE/REPLACE | L Uprr Fuel System Step | N.A. | 160.47 * | 0.5 |
| 25 | 101138 | BDY | REMOVE/REPLACE | L Lwr Fuel System Step | N.A. | 160.47 * | 0.5 |

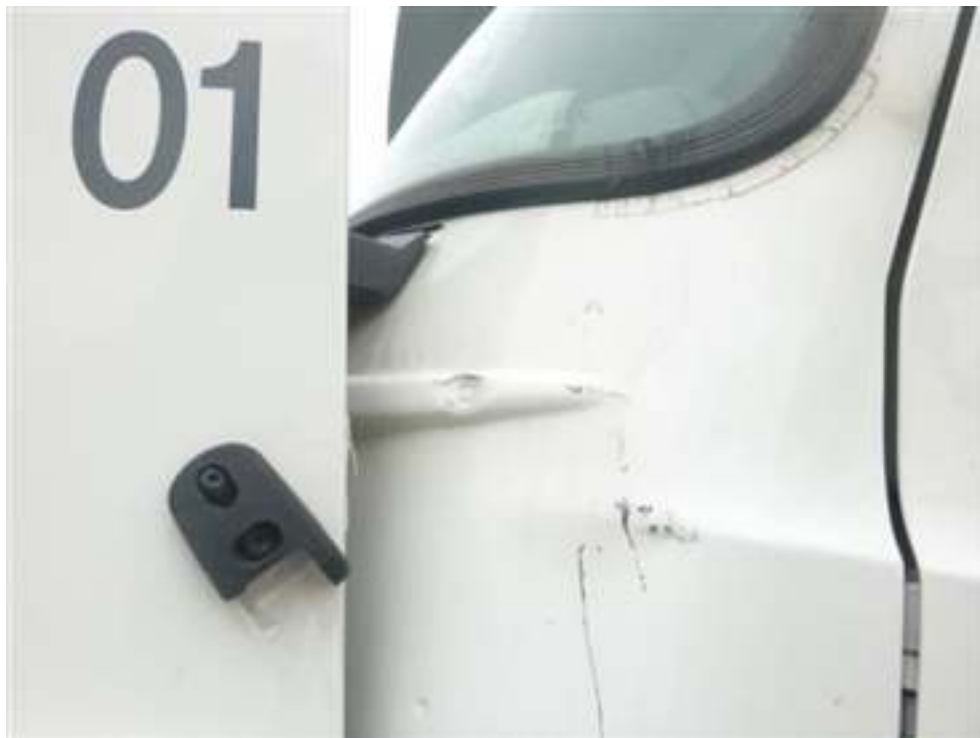
Document Name: P1050462.JPG  
Remarks: Lt side cowel damage

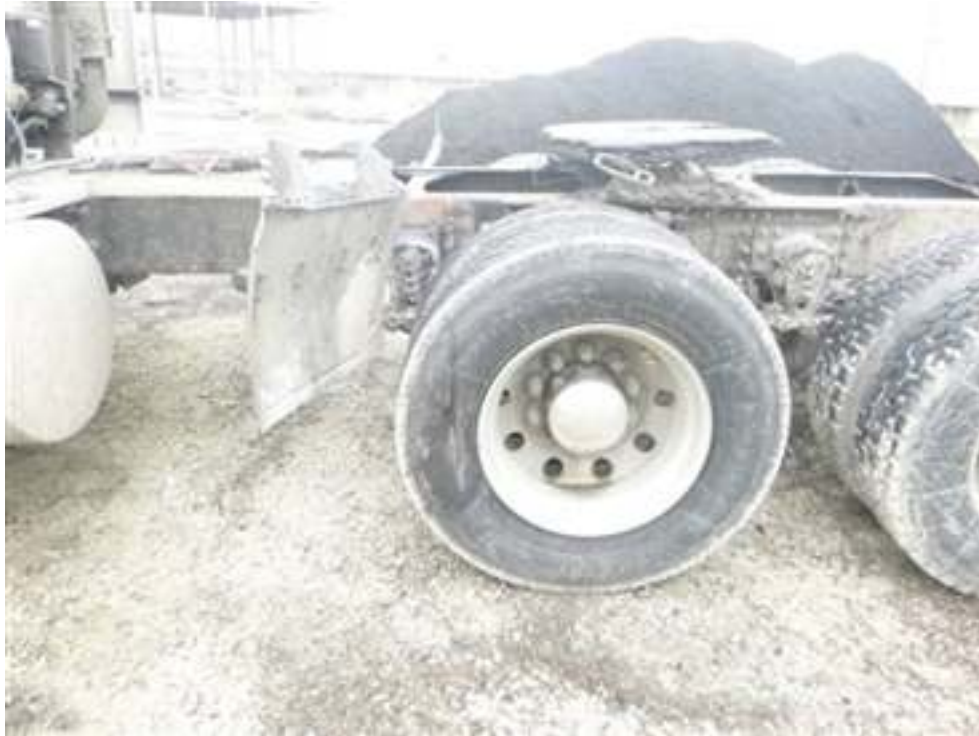
Document Name: P1050466.JPG  
Remarks: Lt frt mudflap and tire damage

| 40 | 100979 | BDY | REMOVE/REPLACE | L Qtr Fender Mud Flap | | N.A. | 13.70 | * | 0.1 |
| 51 | 900500 | MCH * | REMOVE/REPLACE | Lt Rear Frt Outer Recap Tire | | New | 387.00 | * | 0.8* |

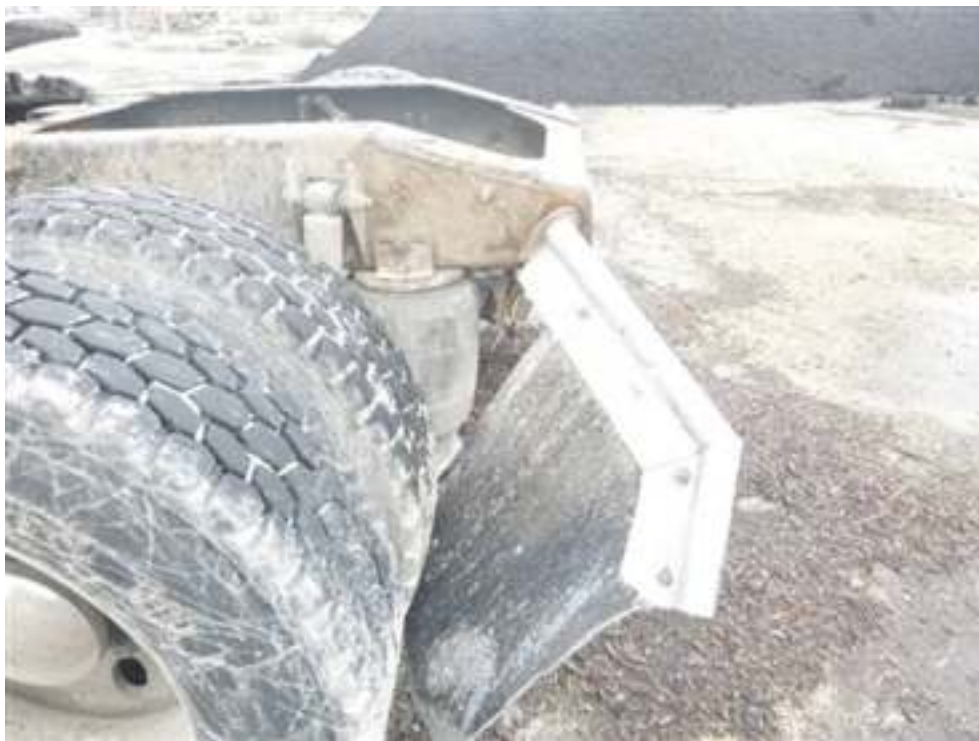
Document Name: P1050467.JPG  
Remarks: Lt re mudflap damage

| 43 | 100998 | BDY | REMOVE/REPLACE | L Rear Mud Flap | | N.A. | 13.70 | * | 0.3 # |
| 44 | 101000 | BDY | REMOVE/REPLACE | L Rear Mud Flap Bracket | | N.A. | 38.00 | * | 0.3 # |

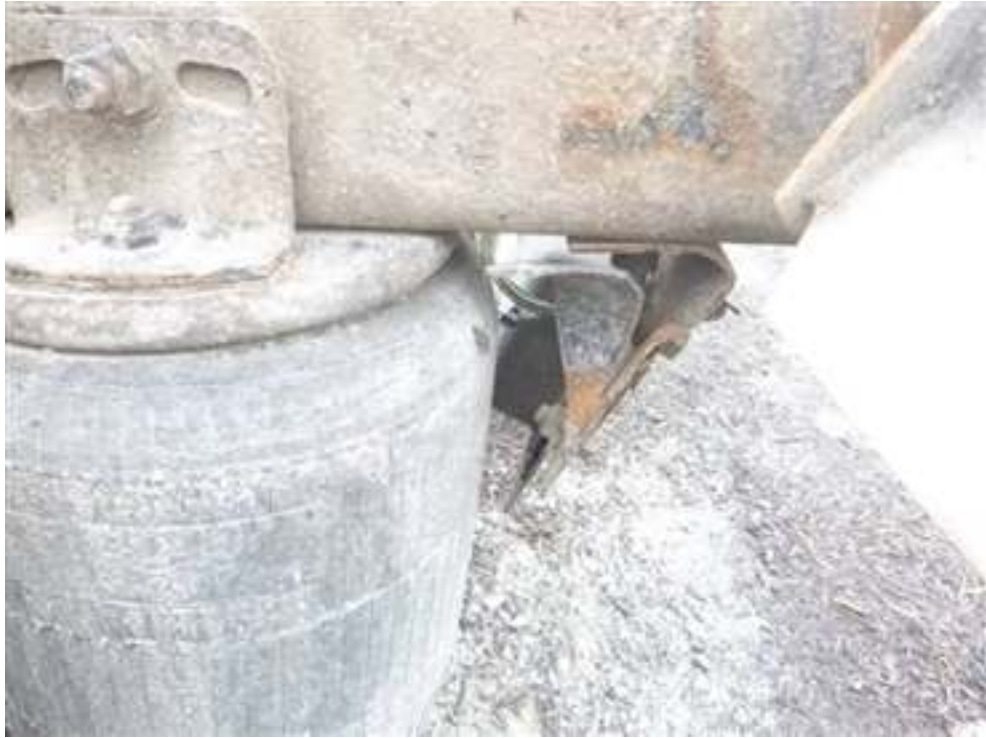
Document Name: P1050468.JPG

Remarks: Rear lamp and crossmember damage

| 45 | 101004 | BDY | REMOVE/REPLACE | L Rear Combination Lamp Assembly | | N.A. | 298.39 | * | 0.4 # |
| 46 | 101008 | BDY | REMOVE/REPLACE | Rear Combination Lamp Mount | | N.A. | 0.00 | * | 0.5 # |
